**Flood Control Project Maintenance
Levee Inspections**

Maintenance Issue Types Only, Levee Inspection Report By Mile - Spring 2019

Reclamation District No. 1600 Mull

Waterway	Bank	Unit Miles	Inspection Start/End	Inspector
Unit No. 01 Sacramento River	Right	10.46	03/05/2019 03/07/2019	Zach Jojola

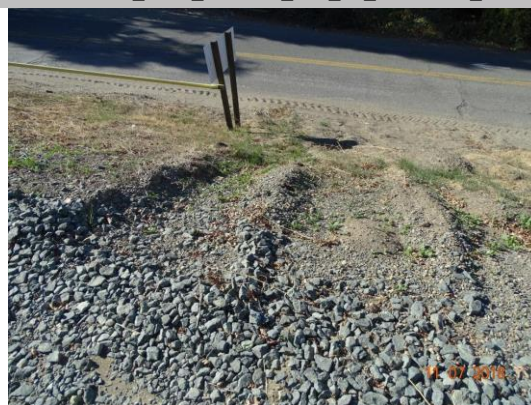
Photo 1 of 1 : SP_2019_RD1600_191_38_20190304_00021.jpg

LM Start	0.11	Rating **	M	Issue No.	38
LM End	0.11	Issue Type +	Ma	Location *	LS
Category	Earthen Levee			GPS Latitude/Longitude	
				Start	End
Item	Slope Stability			38.676524 °	38.676524 °
				-121.631245 °	-121.631245 °
DWR ID	DWR_RD1600_01_f_2018_38				
Comment Code					
S3 : Repair the levee slope damaged by vehicle traffic and prevent access where possible.					
Inspector Comment					
Vehicle ruts on the landside slope.

View of ruts on the landside slope. Fall 2018.

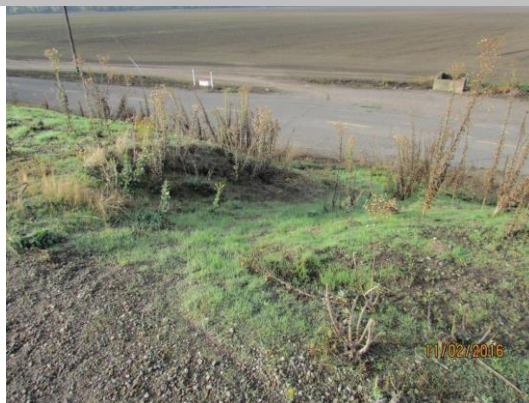
Photo 1 of 1 : SP_2019_RD1600_191_133_20190304_00034.jpg

LM Start	0.53	Rating **	M	Issue No.	133
LM End	0.53	Issue Type +	Ma	Location *	LS
Category	Earthen Levee			GPS Latitude/Longitude	
				Start	End
Item	Slope Stability			38.682140 °	38.682140 °
				-121.634083 °	-121.634083 °
DWR ID	DWR_RD1600_01_f_2013_133				
Comment Code					
S2 : Repair the levee slope damaged by foot traffic and prevent access where possible.					
Inspector Comment					
Footpath on landside slope over pipe crossing.

View of the slope stability site. Fall 2016.

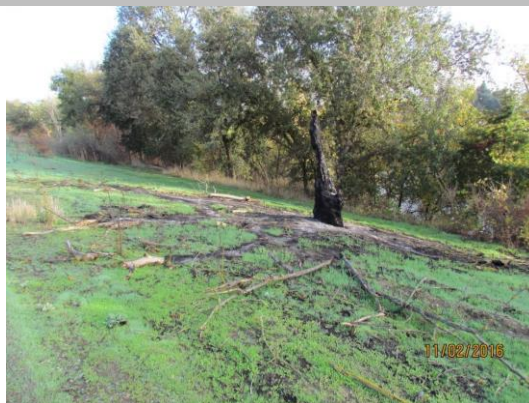
Photo 1 of 1 : SP_2019_RD1600_191_624_20190304_00037.jpg

LM Start	0.78	Rating **	N	Issue No.	624
LM End	0.78	Issue Type +	Ma	Location *	WS
Category	Earthen Levee			GPS Latitude/Longitude	
				Start	End
Item	Trim / Thin Trees			38.685713 °	38.685713 °
				-121.634985 °	-121.634985 °
DWR ID	DWR_RD1600_01_s_2017_624				
Comment Code					
T5 : Tree stumps.					
Inspector Comment					
Burnt stump on waterside slope.

View of burnt tree on waterside slope. Fall 2016.

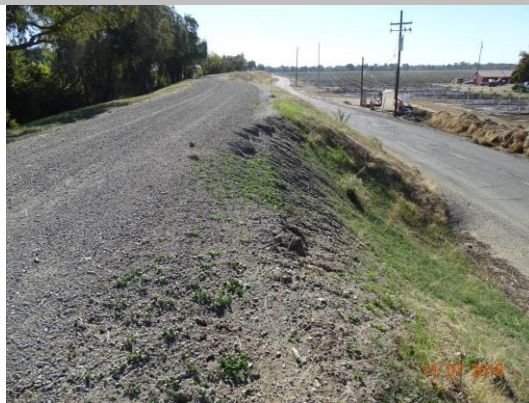
Photo 1 of 2 : SP_2019_RD1600_191_134_20190304_00035.jpg

LM Start	0.97	Rating **	M	Issue No.	134
LM End	0.97	Issue Type +	Ma	Location *	LS
Category	Earthen Levee			GPS Latitude/Longitude	
				Start	End
Item	Erosion / Bank Caving			38.688454 °	38.688454 °
				-121.635528 °	-121.635528 °
DWR ID	DWR_RD1600_01_f_2013_134				
Comment Code					
E2 : Schedule repair of erosion site prior to the next inspection.					
Inspector Comment

View of slope depression and runoff erosion on landside slope. Fall 2018.

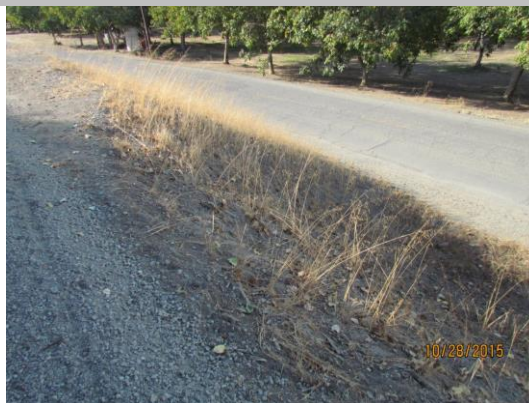
Photo 2 of 2 : SP_2019_RD1600_191_134_20190304_00036.jpg

View of the depression of the slope on the landward side of the levee looking downstream. Fall 2015.

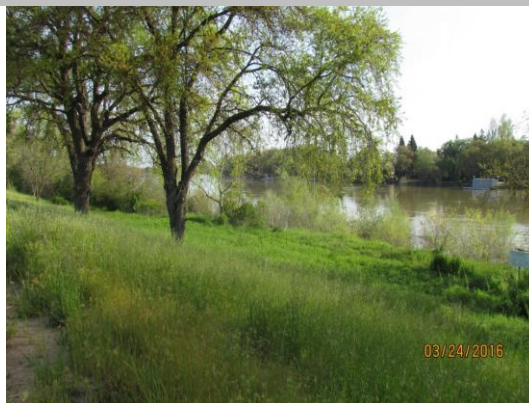
Photo 1 of 2 : SP_2019_RD1600_191_22_20190304_00011.jpg

LM Start	1.01	Rating **	A/W	Issue No.	22
LM End	1.10	Issue Type +	Ma	Location *	WS
Category	Earthen Levee			GPS Latitude/Longitude	
				Start	End
Item	Vegetation			38.689092 °	38.690368 °
				-121.635616 °	-121.635669 °
DWR ID	DWR_RD1600_01_f_2017_22				
Comment Code					
V8 : Environmental Requirements.					
Inspector Comment

View of the revegetation site at the berm edge on the waterward side of the levee looking upstream. Spring 2016.

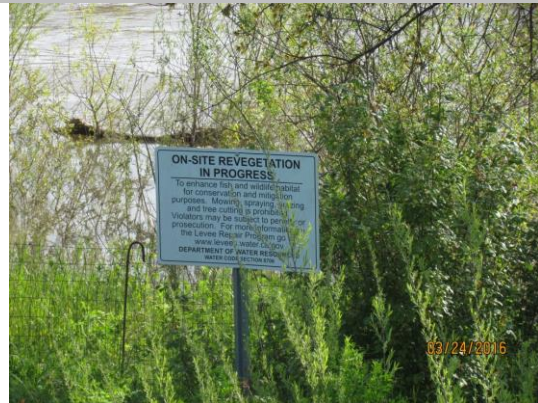
Photo 2 of 2 : SP_2019_RD1600_191_22_20190304_00012.jpg

Sign stating revegetation site. Spring 2016.

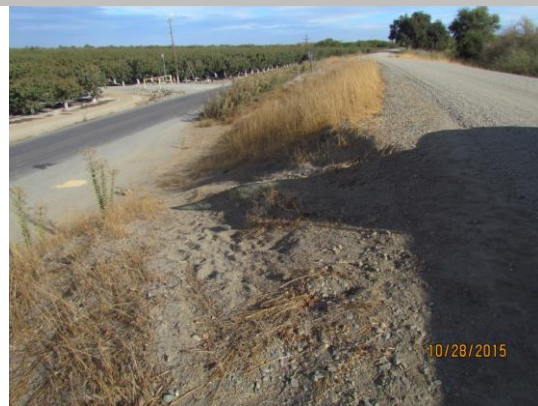
Photo 1 of 1 : SP_2019_RD1600_191_4_20190304_00001.jpg

LM Start	1.40	Rating **	M	Issue No.	4
LM End	1.40	Issue Type +	Ma	Location *	LS
Category	Earthen Levee			GPS Latitude/Longitude	
				Start	End
Item	Slope Stability			38.694452 °	38.694452 °
				-121.634292 °	-121.634292 °
DWR ID	DWR_RD1600_01_s_2017_4				
Comment Code					
S3 : Repair the levee slope damaged by vehicle traffic and prevent access where possible.					
Inspector Comment					
Ruts on the landside slope from vehicles.

View of the slope stability caused by vehicles on the landward side of the levee looking upstream. Fall 2015.

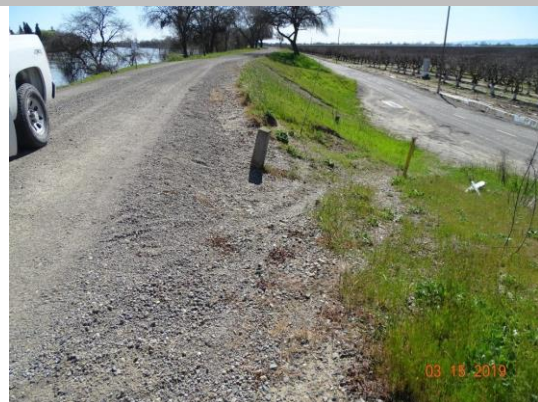
Photo 1 of 1 : SP_2019_RD1600_191_52_20190315_00060.jpg

LM Start	1.42	Rating **	M	Issue No.	52
LM End	1.42	Issue Type +	Ma	Location *	LS
Category	Earthen Levee			GPS Latitude/Longitude	
				Start	End
Item	Slope Stability			38.694728 °	38.694728 °
				-121.634224 °	-121.634224 °
DWR ID	DWR_RD1600_01_f_2018_52				
Comment Code					
S3 : Repair the levee slope damaged by vehicle traffic and prevent access where possible.					
Inspector Comment					
Ruts on the landside slop from vehicles.

View of ruts on landside shoulder. Spring 2019.

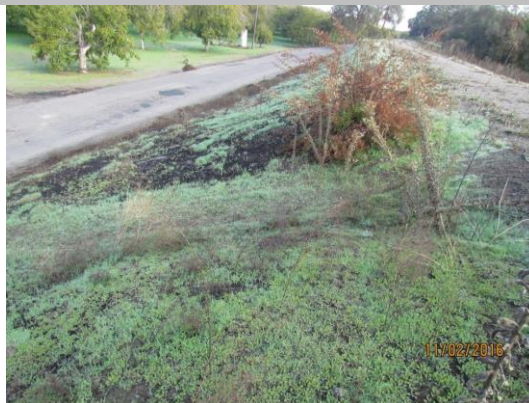
Photo 1 of 1 : SP_2019_RD1600_191_70_20190304_00030.jpg

LM Start	1.70	Rating **	A/W	Issue No.	70
LM End	1.70	Issue Type +	Ma	Location *	LS
Category	Earthen Levee			GPS Latitude/Longitude	
				Start	End
Item	Slope Stability			38.698414 °	38.698414 °
				-121.631874 °	-121.631874 °
DWR ID	DWR_RD1600_01_f_2017_70				
Comment Code					
S2 : Repair the levee slope damaged by foot traffic and prevent access where possible.					
Inspector Comment					
Footpath on landside slope. Recommend monitoring.

View of slope instability. Fall 2016.

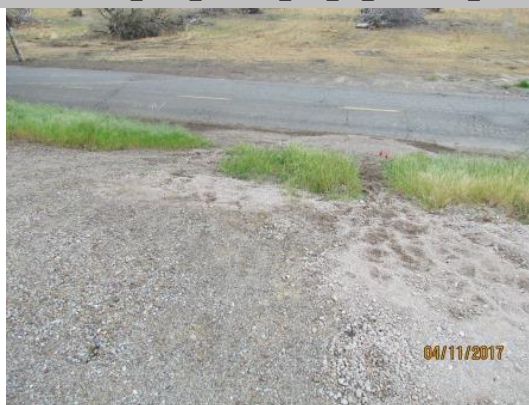
Photo 1 of 1 : SP_2019_RD1600_191_72_20190304_00031.jpg

LM Start	2.01	Rating **	M	Issue No.	72
LM End	2.01	Issue Type +	Ma	Location *	LS
Category	Earthen Levee			GPS Latitude/Longitude	
				Start	End
Item	Erosion / Bank Caving			38.701605 °	38.701605 °
				-121.627954 °	-121.627954 °
DWR ID	DWR_RD1600_01_s_2018_72				
Comment Code					
E2 : Schedule repair of erosion site prior to the next inspection.					
Inspector Comment					
Runoff on landside slope.

View of the erosion site. Spring 2017.

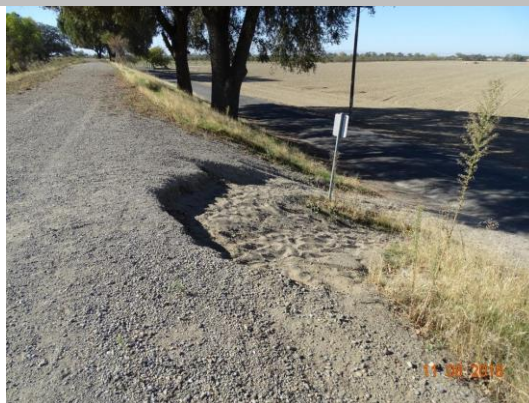
Photo 1 of 1 : SP_2019_RD1600_191_43_20190304_00022.jpg

LM Start	2.40	Rating **	M	Issue No.	43
LM End	2.40	Issue Type +	Ma	Location *	LS
Category	Earthen Levee			GPS Latitude/Longitude	
				Start	End
Item	Erosion / Bank Caving			38.705154 °	38.705154 °
				-121.622231 °	-121.622231 °
DWR ID	DWR_RD1600_01_s_2019_43				
Comment Code					
E2 : Schedule repair of erosion site prior to the next inspection.					
Inspector Comment					
Runoff on the landside slope.

View of runoff on the landside slope. Fall 2018.

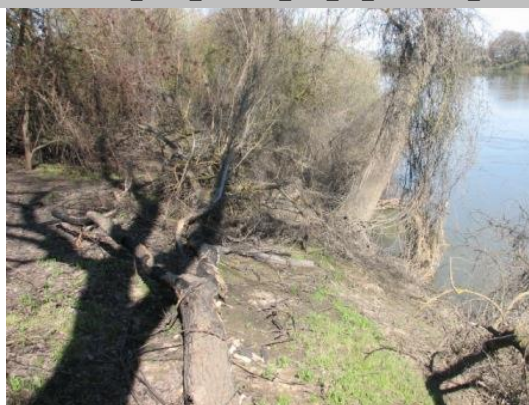
Photo 1 of 2 : SP_2019_RD1600_191_20_20190304_00006.jpg

This another view of the site.

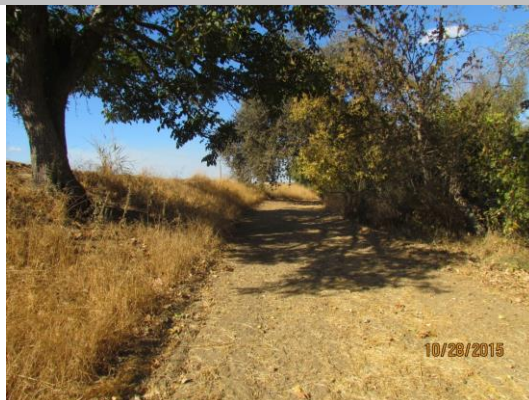
Photo 2 of 2 : SP_2019_RD1600_191_20_20190304_00007.jpg

View of the erosion in the berm area on the waterward side looking upstream. Fall 2015.

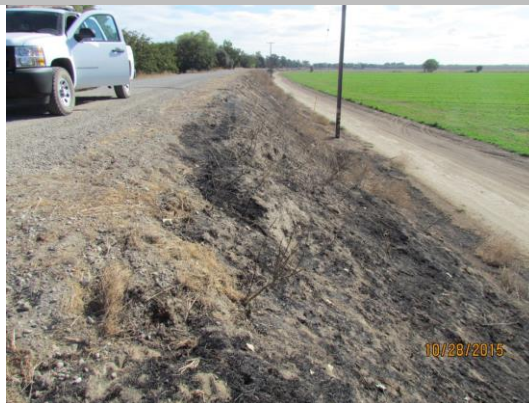
Photo 1 of 1 : SP_2019_RD1600_191_61_20190304_00028.jpg

View of the erosion on the landward side of the levee looking downstream. Fall 2015.

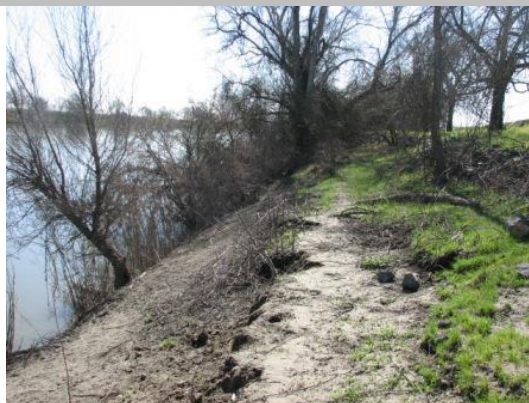
Photo 1 of 3 : SP_2019_RD1600_191_21_20190304_00008.jpg

LM Start	7.23	Rating **	A/W	Issue No.	21
LM End	7.23	Issue Type +	Ma	Location *	WS
Category	Earthen Levee			GPS Latitude/Longitude	
				Start	End
Item	Erosion / Bank Caving			38.768409 °	38.768409 °
				-121.597213 °	-121.597213 °
DWR ID	DWR_RD1600_01_s_2012_21				
Comment Code					
E1 : Note and monitor erosion site.					
Inspector Comment					
Erosion on waterside berm. Not within the prism.

The erosion is eroding away the berm area.

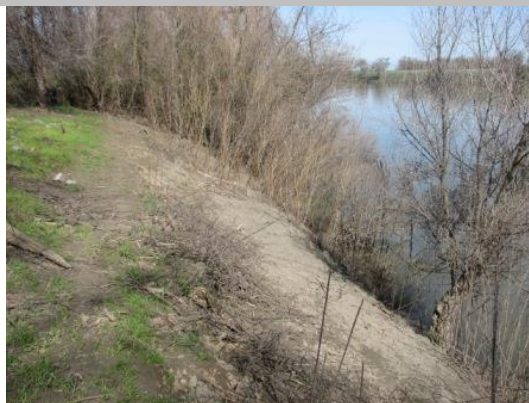
Photo 2 of 3 : SP_2019_RD1600_191_21_20190304_00009.jpg

The bank is eroding away and has become very steep.

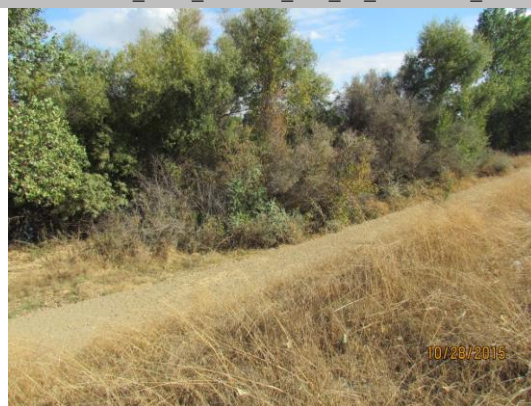
Photo 3 of 3 : SP_2019_RD1600_191_21_20190304_00010.jpg

View of the erosion along the waterward berm of the levee. Fall 2015.

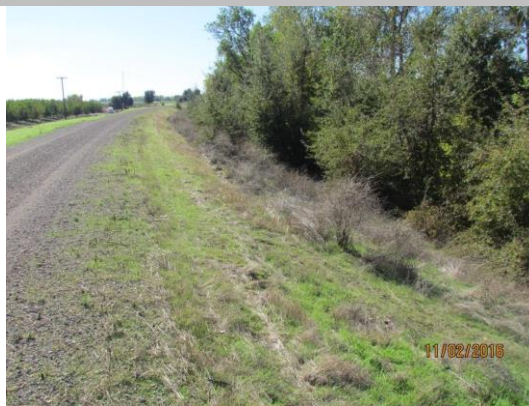
Photo 1 of 1 : SP_2019_RD1600_191_66_20190304_00029.jpg

Vegetation on WS slope has been cleared only about 10 ft. from the crown. Fall 2016.

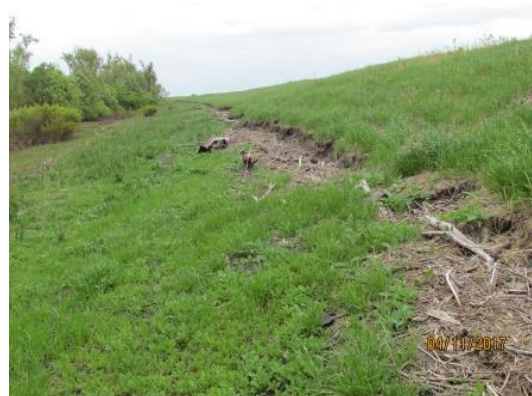
Photo 1 of 1 : SP_2019_RD1600_192_23_20190304_00016.jpg

LM Start	0.92	Rating **	A/W	Issue No.	23
LM End	1.40	Issue Type +	Ma	Location *	WS
Category	Earthen Levee			GPS Latitude/Longitude	
				Start	End
Item	Erosion / Bank Caving			38.722948 °	38.716108 °
				-121.633477 °	-121.634930 °
DWR ID	DWR_RD1600_02_s_2017_23				
Comment Code					
E2 : Schedule repair of erosion site prior to the next inspection.					
Inspector Comment					
Long section of wave wash damage on waterside levee slope.

View of wave wash damage on waterside levee slope. Spring 2017.

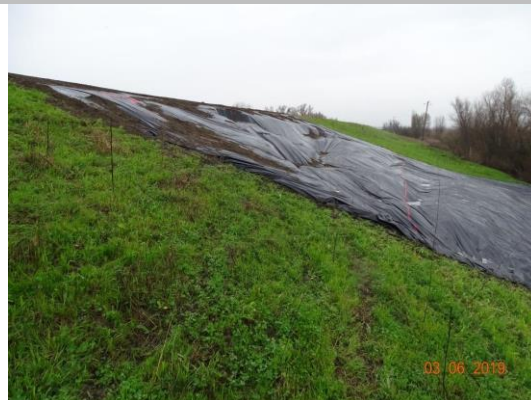
Photo 1 of 2 : SP_2019_RD1600_192_8_20190311_00023.jpg

LM Start	1.56	Rating **	U	Issue No.	8
LM End	1.58	Issue Type +	Ma	Location *	LS
Category	Earthen Levee		GPS Latitude/Longitude		
			Start	End	
Item	Slope Stability		38.713900 °	38.713662 °	
			-121.635817 °	-121.635912 °	
DWR ID	DWR_RD1600_02_s_2019_8				
Comment Code					
S1 : Repair slope instability.					
Inspector Comment					
100' sloughing section with multiple plateaus of exposed scarp. The LMA placed visqueen over the issue and will continue to monitor over the next few months. Recommend repairing after the flood season.

View of sloughing on the landside slope. Spring 2019.

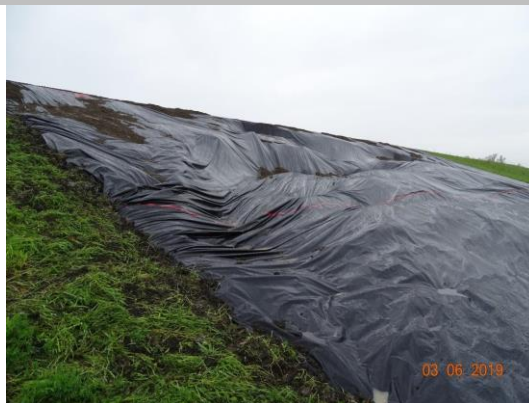
Photo 2 of 2 : SP_2019_RD1600_192_8_20190311_00025.jpg

LM Start	1.56	Rating **	U	Issue No.	8 (cont)	
LM End	1.58	Issue Type +	Ma	Location *	LS	
Category	Earthen Levee			GPS Latitude/Longitude		
				Start		End
Item	Slope Stability			38.713900 °	38.713662 °	
				-121.635817 °	-121.635912 °	
DWR ID	DWR_RD1600_02_s_2019_8					
Comment Code						
S1 : Repair slope instability.						
Inspector Comment						
100' sloughing section with multiple plateaus of exposed scarp. The LMA placed visqueen over the issue and will continue to monitor over the next few months. Recommend repairing after the flood season.

Additional view of sloughing. Spring 2019.

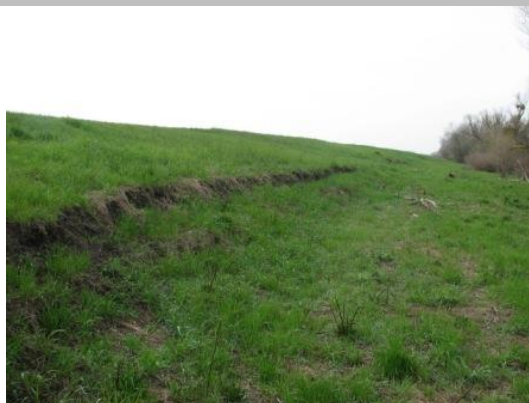
Photo 1 of 4 : SP_2019_RD1600_192_14_20190304_00005.jpg

LM Start	1.79	Rating **	A/W	Issue No.	14
LM End	2.05	Issue Type +	Ma	Location *	WS
Category	Earthen Levee			GPS Latitude/Longitude	
				Start	End
Item	Erosion / Bank Caving			38.710763 °	38.707116 °
				-121.637147 °	-121.638722 °
DWR ID	DWR_RD1600_02_s_2019_14				
Comment Code					
E1 : Note and monitor erosion site.					
Inspector Comment

A closer view of the wave wash damage along the bypass.

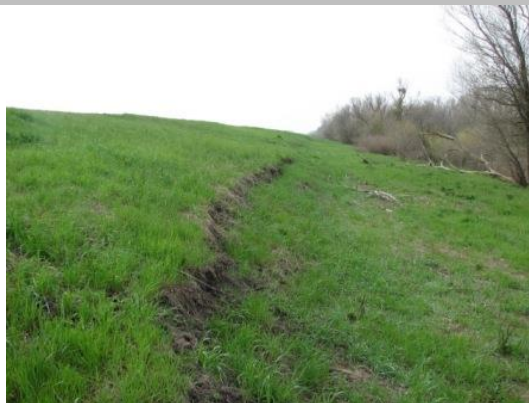
Photo 2 of 4 : SP_2019_RD1600_192_14_20190304_00006.jpg

Wave wash damage along the slope the cut is 1'-2'.

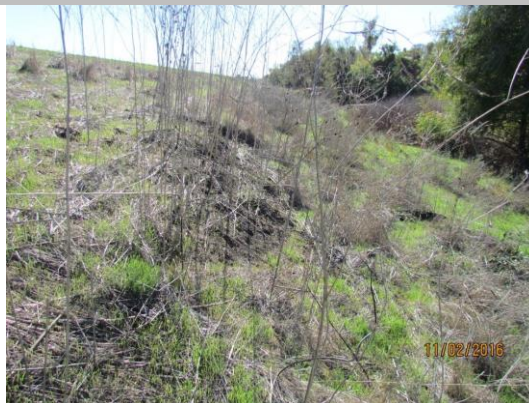
Photo 4 of 4 : SP_2019_RD1600_192_14_20190304_00008.jpg

View of erosion site on WS slope. Fall 2016.

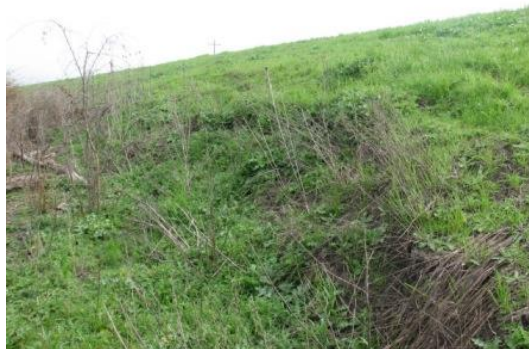
Photo 1 of 3 : SP_2019_RD1600_192_15_20190304_00009.jpg

LM Start	2.16	Rating **	A/W	Issue No.	15
LM End	2.27	Issue Type +	Ma	Location *	WS
Category	Earthen Levee			GPS Latitude/Longitude	
				Start	End
Item	Erosion / Bank Caving			38.705614 °	38.704052 °
				-121.639357 °	-121.640016 °
DWR ID	DWR_RD1600_02_s_2012_15				
Comment Code					
E1 : Note and monitor erosion site.					
Inspector Comment					
Previous erosion site. Recommend monitoring.

Looking upstream a deeper cut of 2'-3' damage.

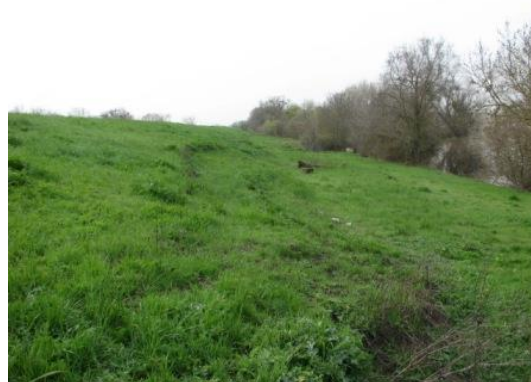
Photo 2 of 3 : SP_2019_RD1600_192_15_20190304_00010.jpg

This is wave wash damage along the toe of the levee looking downstream.

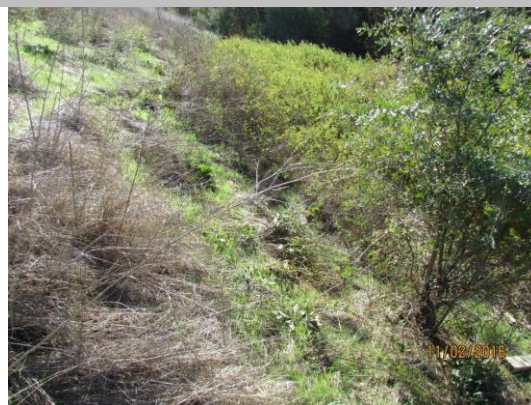
Photo 3 of 3 : SP_2019_RD1600_192_15_20190304_00011.jpg

View of wave wash damage on WS slope. Fall 2016.

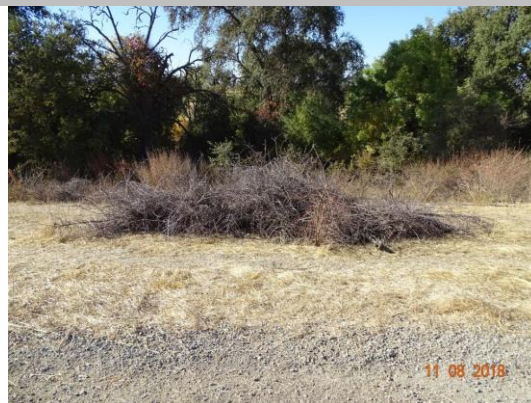
Photo 1 of 1 : SP_2019_RD1600_192_20_20190304_00015.jpg

View of pruning pile on the waterside slope. Fall 2018.

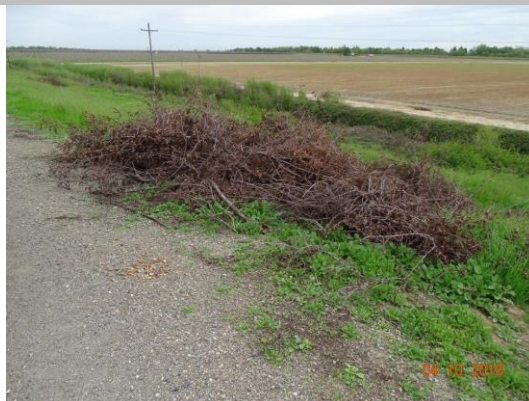
Photo 1 of 1 : SP_2019_RD1600_192_10_20190304_00004.jpg

View of pruning pile on the landside slope. Spring 2018.

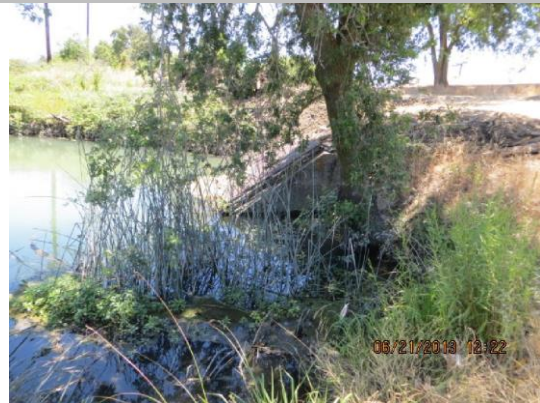
Photo 1 of 3 : UCIP_SP_2019_15303_25158.jpg

Concrete intake structure on LS.

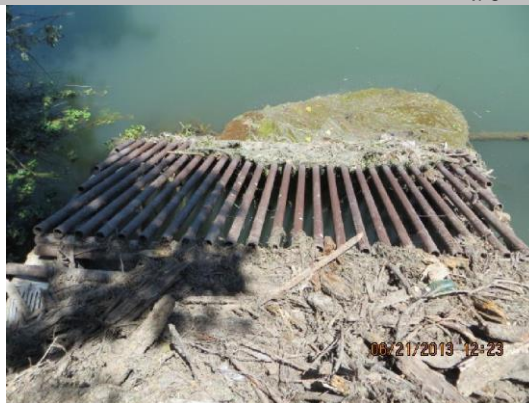
Photo 2 of 3 : UCIP_SP_2019_15303_25157.jpg

Concrete intake structure on LS.

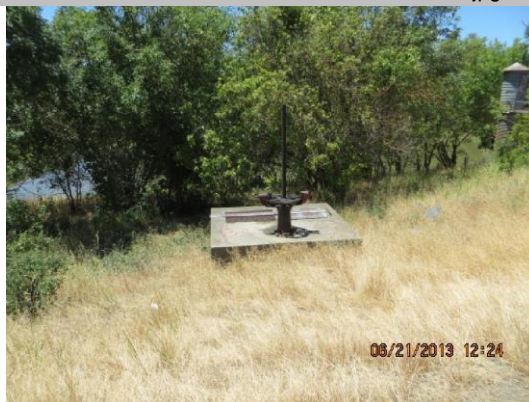
Photo 3 of 3 : UCIP_SP_2019_15303_25156.jpg

Slide gate in 9'x10' concrete box on WS slope.

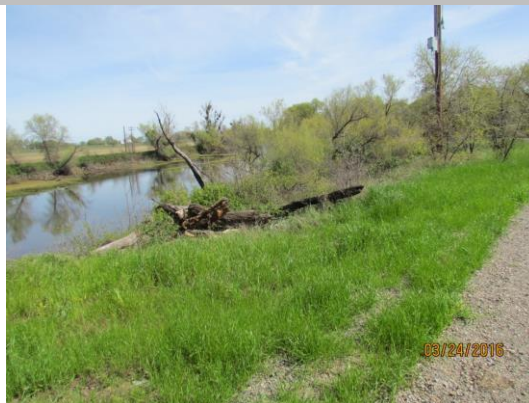
Photo 1 of 2 : SP_2019_RD1600_192_6_20190304_00002.jpg

View of the trees on the landward side of the levee looking downstream. Spring 2016.

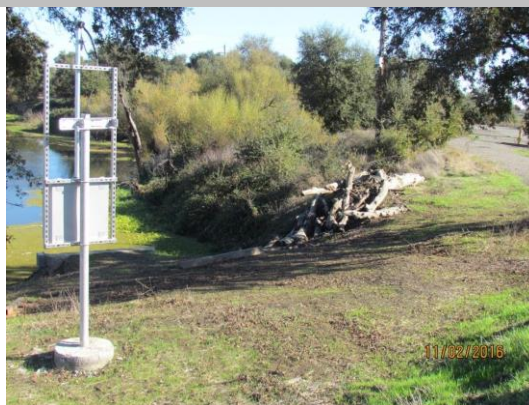
Photo 2 of 2 : SP_2019_RD1600_192_6_20190304_00003.jpg

View of debris on LS slope. Fall 2016.
